# Manhole Inspection Summary

Manhole # S17UU\_006MH

Record Plat: **17UU** Node: **006** Status: **Found**

**Location** Address: **REISTERSTOWN RD**

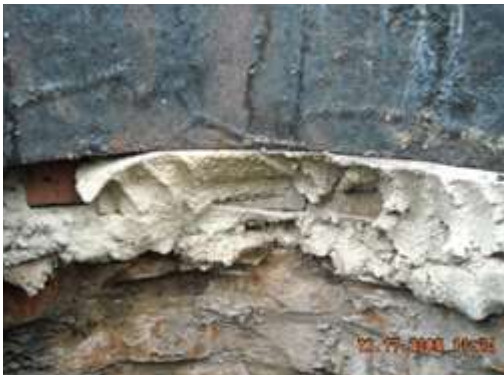
MH FRAME ADJUSTMENT

**Chimney / Frame Adjustment** ☒ Exists Material: **Brick** ☒ Parged Height: **3.5** (in.)

3.5" FRAME ADJUSTMENT

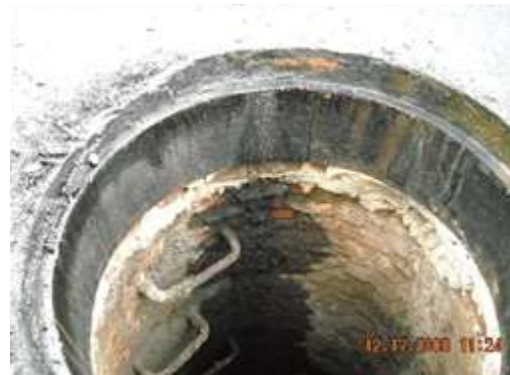
Defect 1

Subject To Ponding: **Sheeting**

EVIDENCE OF INFLOW DUE TO SHEETING OF ROADWAY

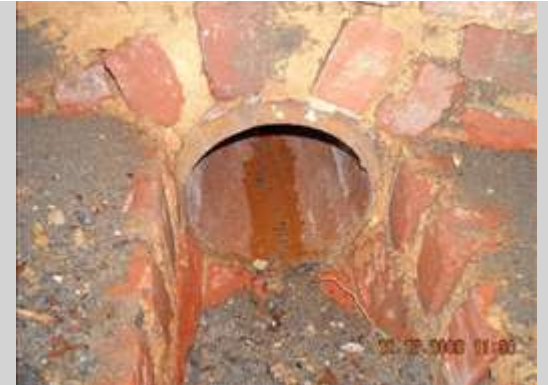
12 O'Clock Outflow

DEBRIS ON BENCH

Pipe Height: **10.8** (in.) Rod and Bar (Angled)  
Pipe Material: **Clay** ☐ Pipe Lined  
Invert Depth: **8.46** (ft.) Flow Characteristics: **None**  
Deposits: ☒ None ☐ **Mud** ☐ Sludge ☐ **Debris** ☐ Grease  
Silt Depth: **4** (in.) Deposits Extent: **Medium**  
Infiltration: **None** Pipe Seal Cond: **Sound**

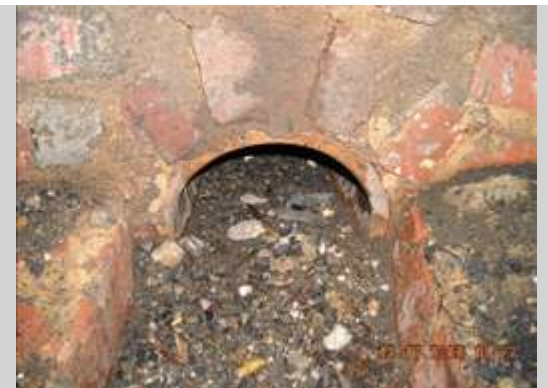
7 O'Clock Inflow

DEBRIS IN CHANNEL

Pipe Height: **8.4** (in.) Rod and Bar (Angled)  
Pipe Material: **Clay** ☐ Pipe Lined  
Invert Depth: **8.17** (ft.) Flow Characteristics: **None**  
Deposits: ☐ None ☒ **Mud** ☐ Sludge ☒ **Debris** ☐ Grease  
Silt Depth: **4** (in.) Deposits Extent: **Medium**  
Infiltration: **None** Pipe Seal Cond: **Sound**
